SOUTH LONDONDERRY SCHOOL

Owner:
Londonderry School
District

Scope of Work:
Wall Moisture
Evaluation

Location: South
Londonderry, New
Hampshire

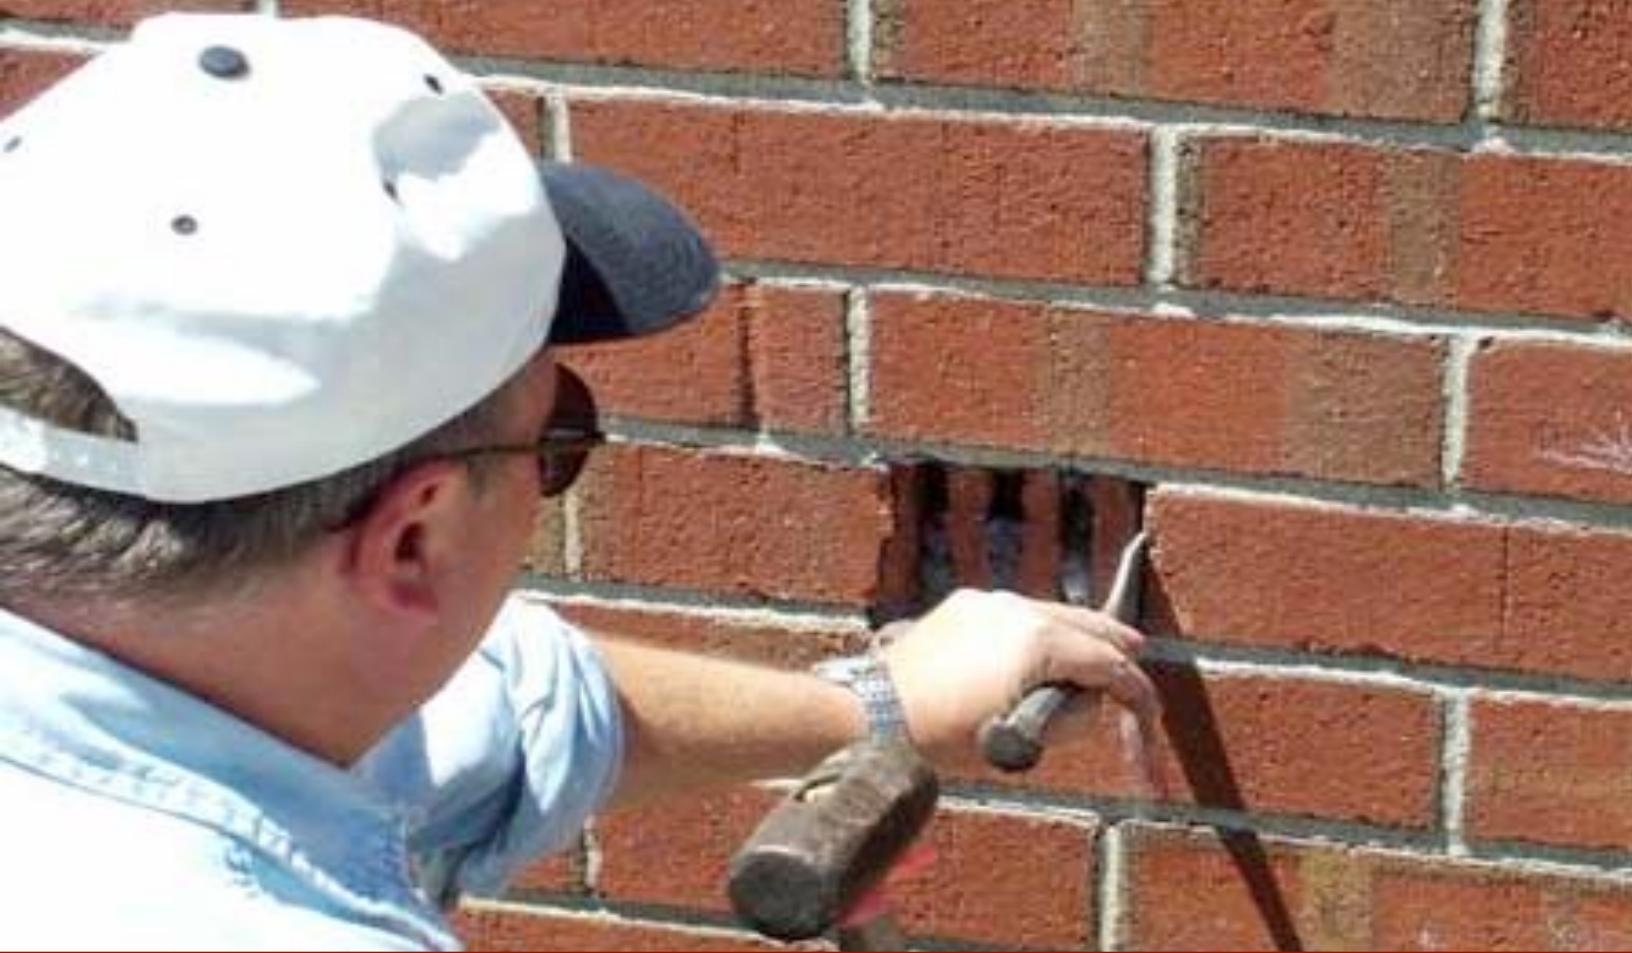
TBS completed a series of building evaluations that found the building windows and louver openings either had flashing failures or no flashing installed. Moisture within the walls promoted mold growth on the exterior sheathing behind the brick facade and the batt insulation as well as the interior sheathing.

An alternative method of wall repair was used. The exterior brick and existing light gauge steel framing remain in place while the interior and exterior sheathing were removed along with the batt insulation. New SPF replaced the existing insulation which also provided a new more efficient air barrier and vapor barrier. A new drainage matt was also installed to maintain a proper drainage plane behind the brick facade
